**Flood Control Project Maintenance
Levee Inspections**

Fall 2019 Levee Maintenance Deficiency Summary Report

San Joaquin River Basin

**Flood Control Project Maintenance
Levee Inspections****LMA District Cover Sheet****Fall 2019 Levee Inspection Results****Reclamation District No. 2058 Pescadero**

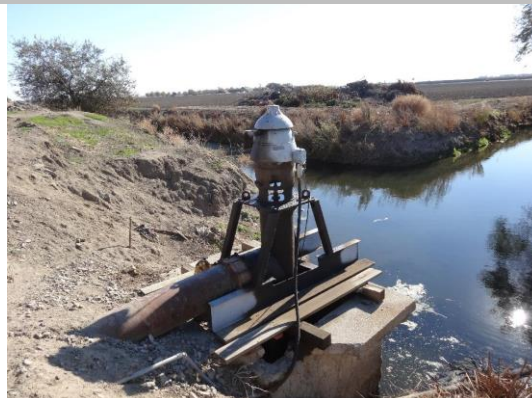
Photo 1 of 3 : UCIP_FA_2019_45843_45165.jpg

Comment Code						
Inspector Comment						
DS_ID:22700						
FS_ID:45843						
EP_NO: 5055						
Repair Type: Non-Urgent						
Crossing Status: Found						
UCIP Comments: Excessive oil leakage.						
FIELD_STRUCT_DESC: 16-inch steel drainage discharge pipe through the levee, 3.8 feet below the crown. Drainage ditch on the landside (LS). Pump on a concrete sump on the LS. Siphon breaker under protective cover on the waterside (WS) slope. (To abandon the existing 12-inch pipe with concrete and install a new 16-inch pipe authorized under Permit No. 5055, 1965 - Stanley Electric Motor Company). 12-inch pipe grouted in place. [Additional Reference(s): DWR Levee Log, 2005. USACE San Joaquin O&M Manual 10, March 1964, (HLM 0.72)].						
FS Date: 5/12/2015

LS view: exposed pipe and vertical pump on concrete sump on drain ditch.

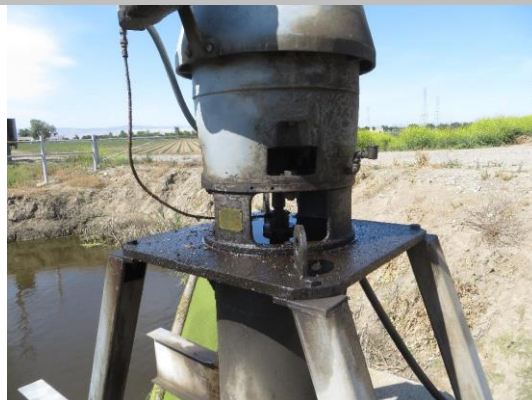
Photo 2 of 3 : UCIP_FA_2019_45843_74061.jpg

LS view: closeup of pump showing excessive oil leakage.

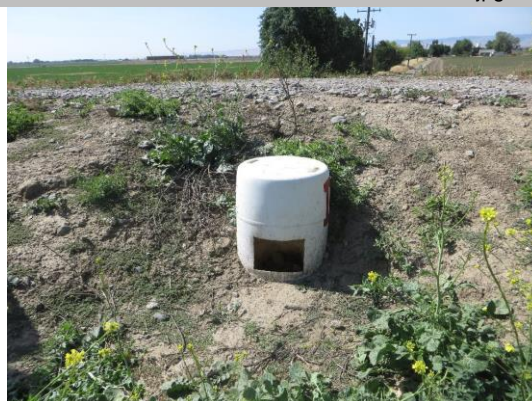
Photo 3 of 3 : UCIP_FA_2019_45843_74060.jpg

Comment Code						
Inspector Comment						
DS_ID:22700 FS_ID:45843 EP_NO: 5055 Repair Type: Non-Urgent Crossing Status: Found UCIP Comments: Excessive oil leakage. FIELD_STRUCT_DESC: 16-inch steel drainage discharge pipe through the levee, 3.8 feet below the crown. Drainage ditch on the landside (LS). Pump on a concrete sump on the LS. Siphon breaker under protective cover on the waterside (WS) slope. (To abandon the existing 12-inch pipe with concrete and install a new 16-inch pipe authorized under Permit No. 5055, 1965 - Stanley Electric Motor Company). 12-inch pipe grouted in place. [Additional Reference(s): DWR Levee Log, 2005. USACE San Joaquin O&M Manual 10, March 1964, (HLM 0.72)]. FS Date: 5/12/2015

WS view: siphon breaker in protective casing.

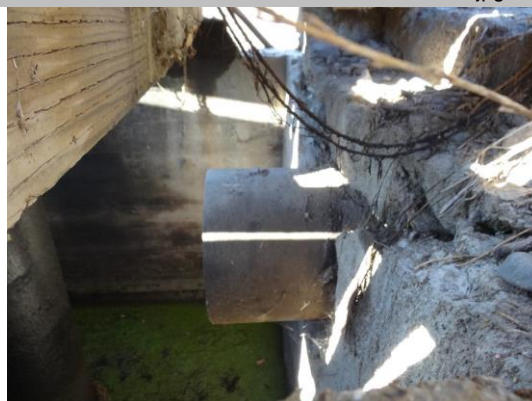
Photo 1 of 1 : UCIP_FA_2019_53531_45168.jpg

Item	DRAFT DWR UCIP LMA Responsibility		37.801792 °	37.801792 °								
			-121.410921 °	-121.410921 °								
DWR ID	22704											
Comment Code												
Inspector Comment												
DS_ID:22704 FS_ID:53531 EP_NO: N/A Repair Type: No Action Needed Crossing Status: Found UCIP Comments: 12/07/2018 Need updated photos to show proper 12-inch pipe abandonment. If crossing was abandoned properly crossing will need to be removed from the LMA responsibility list. Also recommend updating photos for dsid 22700 (16-inch pipe) authorized under the same permit. (O. Magana - DWR UCIP) FIELD_STRUCT_DESC: *ABANDONED* 12-inch drainage discharge pipe of an unknown material through the levee, 18 feet below the crown. Pump on the landside (LS). Flap gate on the waterside (WS). (To abandon the existing 12-inch pipe with concrete and install a new 16-inch pipe authorized under Permit No. 5055, 1965 - Stanley Electric Motor Company). 12-inch pipe grouted in place. [Additional Reference(s): DWR Levee Log, 2005. USACE San Joaquin O&M Manual 10, March 1964, (HLM 0.72)]. FS Date: 5/12/2015

LS view: an abandoned pipe found in concrete sump.

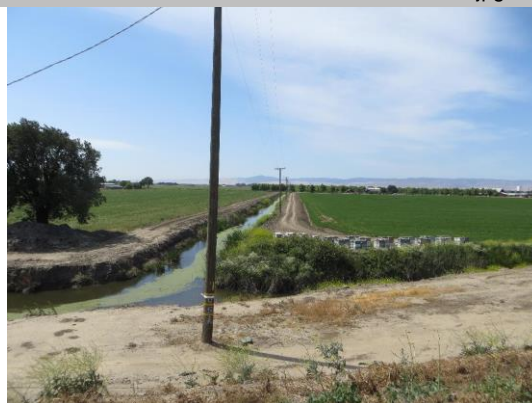
Photo 1 of 1 : UCIP_FA_2019_45847_74322.jpg

LM Start	1.21	Rating **	M	Issue No.	977	
LM End	1.21	Issue Type +	En	Location *		
Category	Supplemental			GPS Latitude/Longitude		
				Start	End	
Item	DRAFT DWR UCIP Field Study			37.802249 °	37.802249 °	
				-121.402183 °	-121.402183 °	
DWR ID	22693					
Comment Code						
Inspector Comment						
DS_ID:22693						
FS_ID:45847						
EP_NO: 10426						
Repair Type: Non-Urgent						
Crossing Status: Indicator Found						
UCIP Comments: Crossing needs to be marked.						
FIELD_STRUCT_DESC: 33-inch concrete encased steel sewer line through the levee, 17 feet below the crown. Manholes visible along Delta Avenue, but no other indicators visible at the levee. (Sewer line authorized under Permit No. 10426, 1975 - City of Tracy, care of CDM, Inc.). [Additional Reference(s): DWR Levee Log, 2005].						
FS Date: 5/12/2015

View of LS. Alignment of Crossing to right of canal at dirt access road.

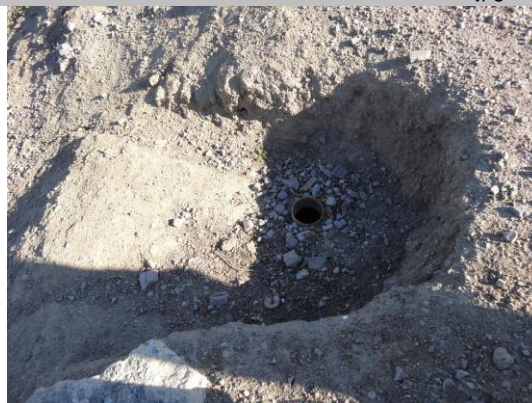
Photo 1 of 3 : UCIP_FA_2019_53374_45171.jpg

Comment Code					
Inspector Comment					
DS_ID:22694 FS_ID:53374 EP_NO: 11546 Repair Type: Urgent Crossing Status: Found UCIP Comments: 10/12/2018 Same as last inspection; keeping as Urgent due to erosion into levee prism (D. Sanoski - DWR UCIP).11/29/2016 Heavy erosion still present. Could be due to wave run-up as this is the only spot on levee not rock revetted. Greg Pombo (RD2058) indicated permits for endangered species prevent rock revetment. (K. Fazel - UCIP)05/12/2015 Erosion on west side of pipe at W/S toe. (K. Fazel - UCIP) FIELD_STRUCT_DESC: 1 of 2: 18-inch steel drainage discharge pipe through the levee, 2 feet below the crown. Pump in drainage ditch on the landside (LS). Siphon breaker with cover on the waterside (WS) shoulder. Electrical service pole at the LS toe. (18-inch pipe and pump authorized under Permit No. 11546, 1976 - Reclamation District No. 2058). [Additional Reference(s): DWR Levee Log, 2005]. FS Date: 10/12/2018 9:59:00 AM

WS view: siphon breaker hole. Siphon breaker removed for repair.

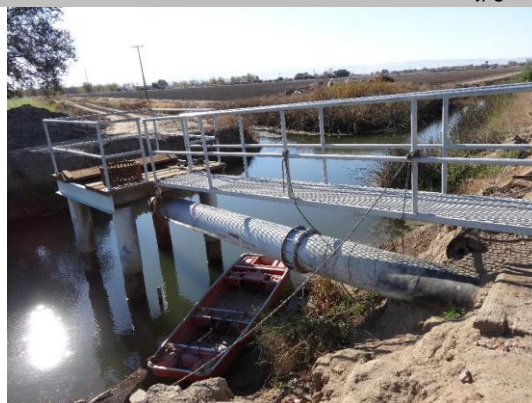
Photo 2 of 3 : UCIP_FA_2019_53374_45170.jpg

Comment Code						
Inspector Comment						
DS_ID:22694 FS_ID:53374 EP_NO: 11546 Repair Type: Urgent Crossing Status: Found UCIP Comments: 10/12/2018 Same as last inspection; keeping as Urgent due to erosion into levee prism (D. Sanoski - DWR UCIP). 11/29/2016 Heavy erosion still present. Could be due to wave run-up as this is the only spot on levee not rock revetted. Greg Pombo (RD2058) indicated permits for endangered species prevent rock revetment. (K. Fazel - UCIP) 05/12/2015 Erosion on west side of pipe at W/S toe. (K. Fazel - UCIP) FIELD_STRUCT_DESC: 1 of 2: 18-inch steel drainage discharge pipe through the levee, 2 feet below the crown. Pump in drainage ditch on the landside (LS). Siphon breaker with cover on the waterside (WS) shoulder. Electrical service pole at the LS toe. (18-inch pipe and pump authorized under Permit No. 11546, 1976 - Reclamation District No. 2058). [Additional Reference(s): DWR Levee Log, 2005]. FS Date: 10/12/2018 9:59:00 AM

LS view: pipe, pile structure, and pump platform in drain ditch.

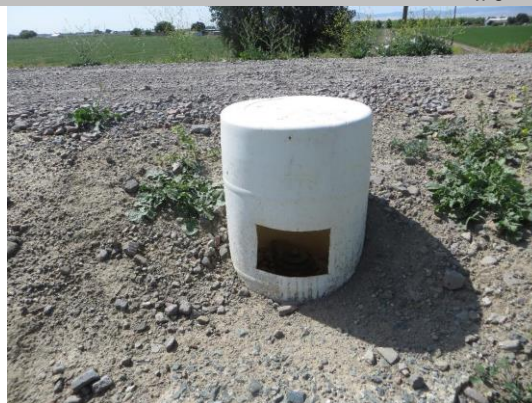
Photo 3 of 3 : UCIP_FA_2019_53374_74320.jpg

Siphon Breaker on WS shoulder.

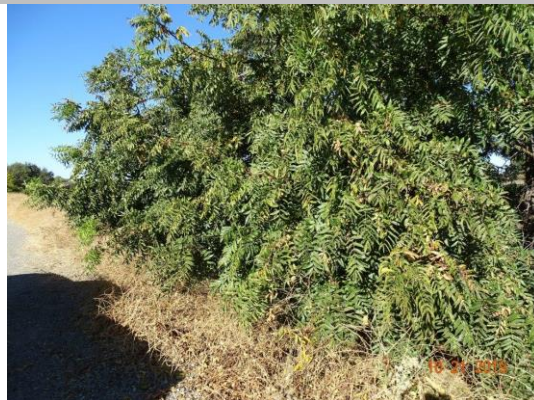
Photo 1 of 1 : FA_2019_RD2058_111_39_20191027_00056.jpg

View of waterside walnut tree. Tree needs to be thinned and trimmed.
Fall 2019

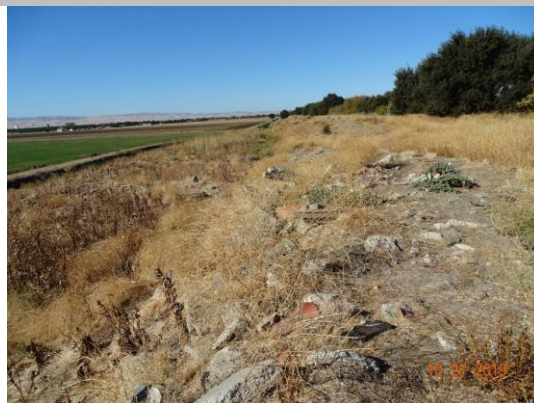
Photo 1 of 2 : FA_2019_RD2058_111_11_20191027_00057.jpg

View of concrete rubble on landside slope. Fall 2019

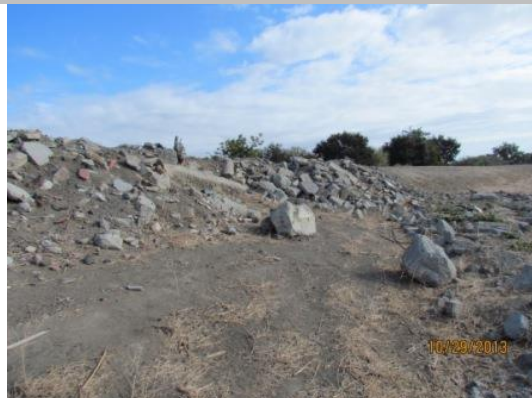
Photo 2 of 2 : FA_2019_RD2058_111_11_20190830_00005.jpg

View of the concrete with rebar placed on the landside slope.

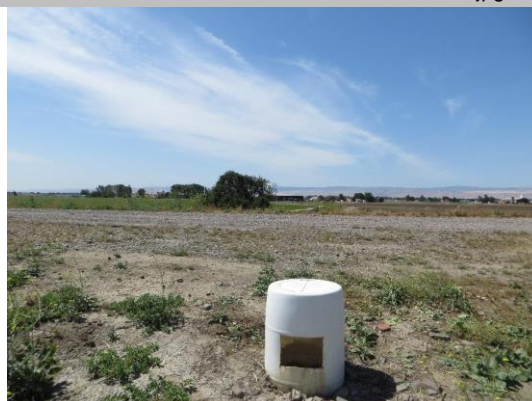
Photo 1 of 3 : UCIP_FA_2019_45865_74323.jpg

LM Start	2.12	Rating **	A/W	Issue No.	979
LM End	2.12	Issue Type +	Ma	Location *	
Category	Supplemental			GPS Latitude/Longitude	
				Start	End
Item	DRAFT DWR UCIP LMA Responsibility			37.803892 °	37.803892 °
				-121.386299 °	-121.386299 °
DWR ID	22705				
Comment Code					
Inspector Comment					
DS_ID:22705					
FS_ID:45865					
EP_NO: N/A					
Repair Type: No Action Needed					
Crossing Status: Found					
UCIP Comments:					
FIELD_STRUCT_DESC: 20-inch steel drainage discharge pipe through the levee, 8 feet below the crown. Pump on a concrete sump in a drainage ditch on the landside (LS) toe. Siphon breaker on the waterside (WS) shoulder. [Additional Reference(s): USACE San Joaquin O&M Manual 10, March 1964, (HLM 2.14), 18-inch pipe referenced].					
FS Date: 5/12/2015

Siphon breaker on WS shoulder inside protective riser.

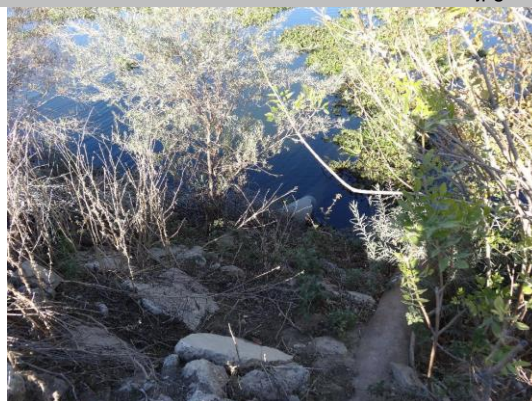
Photo 2 of 3 : UCIP_FA_2019_45865_74324.jpg

Pipe just visible at WS toe at center of photograph.

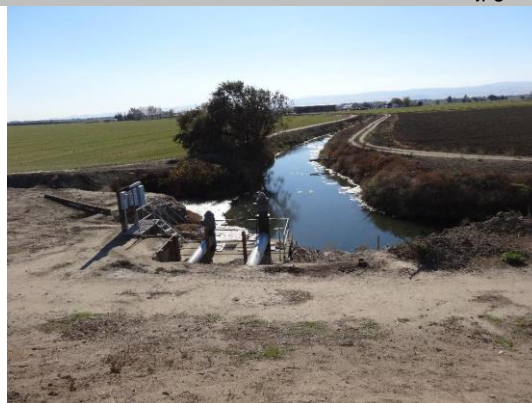
Photo 3 of 3 : UCIP_FA_2019_45865_74325.jpg

Pump on concrete pad at LS toe.

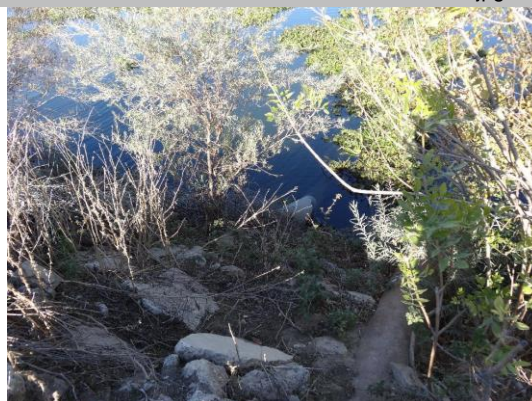
Photo 1 of 3 : UCIP_FA_2019_51699_45192.jpg

LM Start	2.12	Rating **	M	Issue No.	980	
LM End	2.12	Issue Type +	Ma	Location *		
Category	Supplemental			GPS Latitude/Longitude		
				Start		End
Item	DRAFT DWR UCIP LMA Responsibility			37.803886 °		37.803886 °
				-121.386271 °		-121.386271 °
DWR ID	22706					
Comment Code						
Inspector Comment						
DS_ID:22706 FS_ID:51699 EP_NO: N/A Repair Type: Non-Urgent Crossing Status: Found UCIP Comments: Leaky and damaged siphon breaker on waterside shoulder.. FIELD_STRUCT_DESC: 16-inch steel drainage discharge pipe through the levee, 8 feet below the crown. Pump on a concrete sump in a drainage ditch on the landside (LS) toe. Siphon breaker on the waterside (WS) shoulder. [Additional Reference(s): USACE San Joaquin O&M Manual 10, March 1964, (HLM 2.14), 12-inch pipe referenced]. FS Date: 5/13/2015

WS view: exposed steel pipe (right) on channel bank.

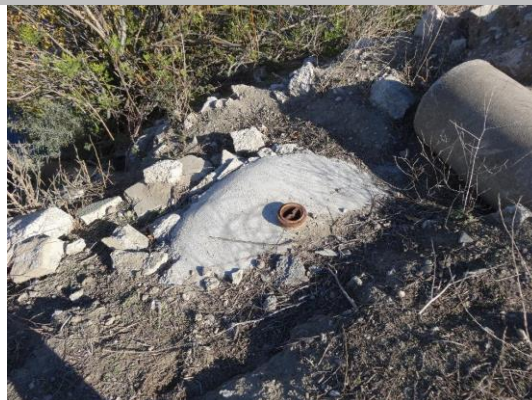
Photo 2 of 3 : UCIP_FA_2019_51699_45191.jpg

WS view: siphon breaker on concrete pad on levee slope.

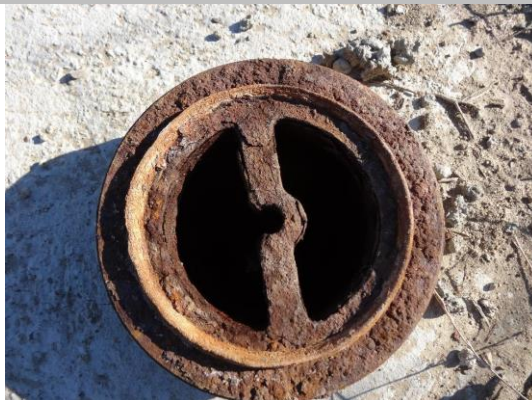
Photo 3 of 3 : UCIP_FA_2019_51699_45190.jpg

WS view: Upper part of the siphon breaker missing.

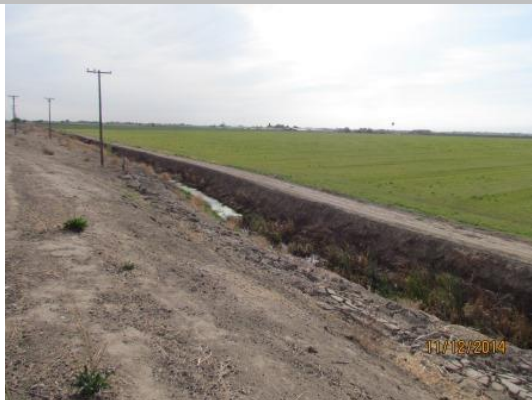
Photo 1 of 1 : FA_2019_RD2058_111_12_20190830_00006.jpg

LM Start	2.24	Rating **	M	Issue No.	12
LM End	2.30	Issue Type +	En	Location *	LS
Category	Earthen Levee			GPS Latitude/Longitude	
				Start	End
Item	Encroachments			37.803375 °	37.803136 °
				-121.384196 °	-121.383078 °
DWR ID	DWR_RD2058_01_f _ 2013_12				
Comment Code					
DT : Ditch					
Inspector Comment

View of the ditch at the landside levee toe.

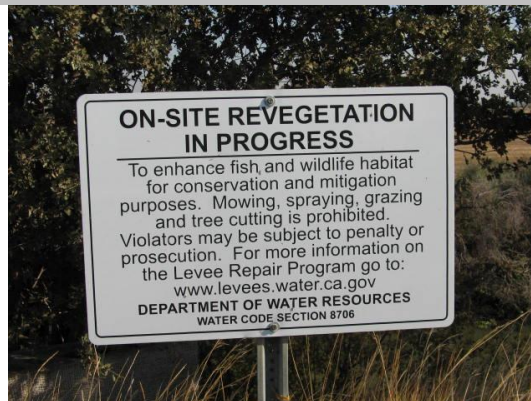
Photo 1 of 1 : FA_2019_RD2058_111_20_20190830_00011.jpg

11/08/2011 Revegetation site, cannot trim or cut vegetation in this area.

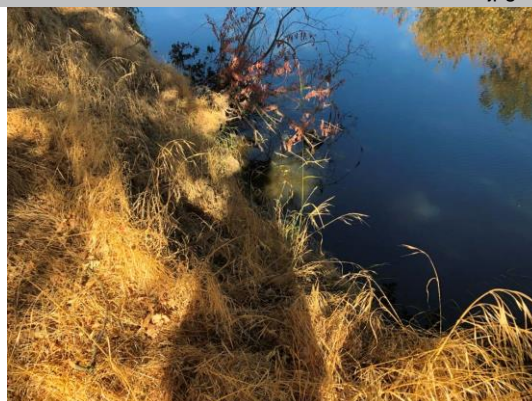
Photo 1 of 3 : SJR2019_RD2058U01RM3.97_1.jpg

Comment Code						
Inspector Comment						
Site ID: RD2058U01RM3.97						
09/25/2019: No significant change observed.						
10/10/2017: No significant change observed.						
07/20/2016: No significant change observed.						
08/04/2015: No significant change observed.						
08/26/2014: No significant change observed.						
08/28/2013: No significant change observed.						
07/26/2012: The site has been visited, and no significant change has been observed.						
09/02/2011: This site was not visited due to the time limit.						
09/22/2010: No significant change observed. Minor pocket erosions are lined at the lower bank. Two large Oak and Willow trees are on mid-slope and bench. The remaining bench was re-measured and found to be approximately 10 feet. There was no indication of active erosion on site during the site visit.						
08/05/2010: Recommended for annual assessment and monitoring of the site during flood events, per CLRO.

07/23/2009: No major change observed since last visit; site is a 200-ft. long near-vertical berm erosion; recommend annual assessment and monitoring of the erosion site, per CLRO CES Evaluation 2008 Report; Site # is the same site previously reported as RM4.0,LM4.51; previously rated "U".						
09/10/2008: Two large trees (2-3' DBH) with partial roots exposed.						
2007: Visited site 03/13/2007.

Direct view of the pocket erosion site.

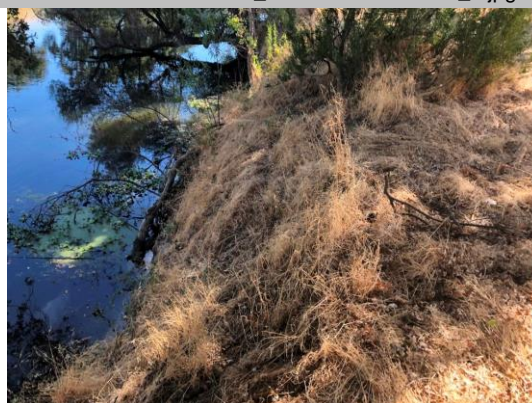
Photo 2 of 3 : SJR2019_RD2058U01RM3.97_2.jpg

Direct view of the erosion near a tree.

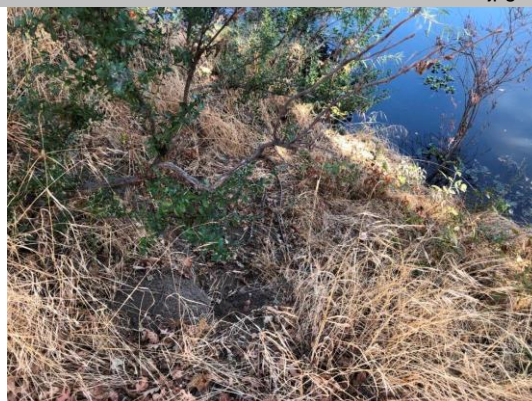
Photo 3 of 3 : SJR2019_RD2058U01RM3.97_4.jpg

Comment Code						
Inspector Comment						
Site ID: RD2058U01RM3.97						
09/25/2019: No significant change observed.						
10/10/2017: No significant change observed.						
07/20/2016: No significant change observed.						
08/04/2015: No significant change observed.						
08/26/2014: No significant change observed.						
08/28/2013: No significant change observed.						
07/26/2012: The site has been visited, and no significant change has been observed.						
09/02/2011: This site was not visited due to the time limit.						
09/22/2010: No significant change observed. Minor pocket erosions are lined at the lower bank. Two large Oak and Willow trees are on mid-slope and bench. The remaining bench was re-measured and found to be approximately 10 feet. There was no indication of active erosion on site during the site visit.						
08/05/2010: Recommended for annual assessment and monitoring of the site during flood events, per CLRO.

07/23/2009: No major change observed since last visit; site is a 200-ft. long near-vertical berm erosion; recommend annual assessment and monitoring of the erosion site, per CLRO CES Evaluation 2008 Report; Site # is the same site previously reported as RM4.0,LM4.51; previously rated "U".						
09/10/2008: Two large trees (2-3' DBH) with partial roots exposed.						
2007: Visited site 03/13/2007.

Close-up view of the erosion.

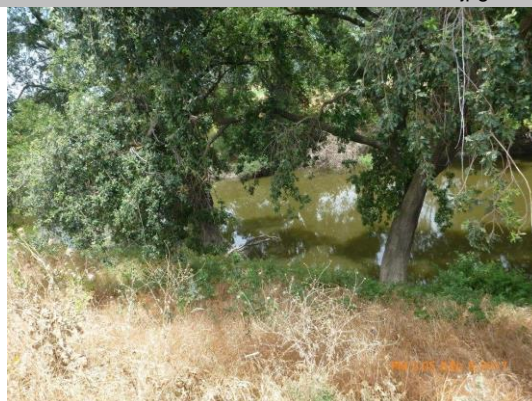
Photo 3 of 3 : LEVAL_FA_2019_82_1355.jpg

LM Start	4.63	Rating **	A/W	Issue No.	43 (cont)
LM End		Issue Type +	Ma	Location *	WS
Category	Supplemental			GPS Latitude/Longitude	
				Start	End
Item	2017 Storm Damage			37.787800 °	°
				-121.350860 °	°
DWR ID	LMA-36				
Comment Code					
Inspector Comment					
Levee Evaluation Comments Description: Site ID No:82 Site Designation:LMA-36 Repair Type: Erosion Rating:Area of Concern Field Date:6/8/2017 Notes: vegetation too dense to evaluate damage. Erosion on the waterside is greater than three feet tall into the levee prism as of Fall 2017 Inspection. Turned back over to Evaluators for re-assessment.

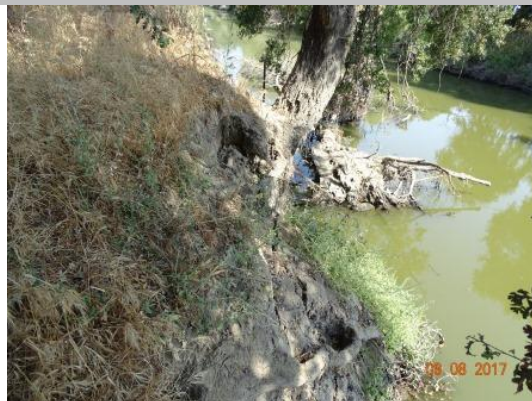
Photo 1 of 5 : FA_2019_RD2058_111_40_20190830_00022.jpg

LM Start	4.63	Rating **	A/W	Issue No.	40
LM End	4.76	Issue Type +	Ma	Location *	WS
Category	Earthen Levee			GPS Latitude/Longitude	
				Start	End
Item	Erosion / Bank Caving			37.787756 °	37.785971 °
				-121.350851 °	-121.350372 °
DWR ID	DWR_RD2058_01_f_2017_40				
Comment Code					
E2 : Schedule repair of erosion site prior to the next inspection.					
Inspector Comment					
Erosion on the waterside is greater than three feet tall into the levee prism.

Downstream view of the erosion.

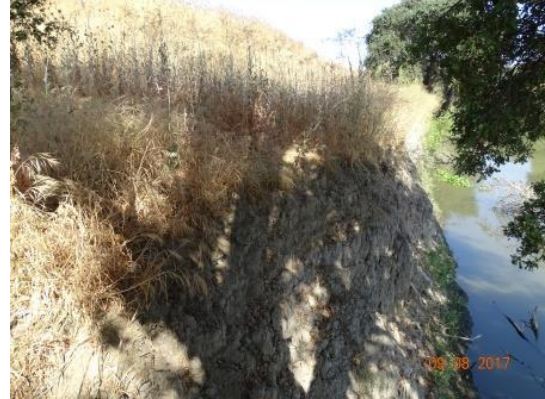
Photo 2 of 5 : FA_2019_RD2058_111_40_20190830_00023.jpg

LM Start	4.63	Rating **	A/W	Issue No.	40 (cont)	
LM End	4.76	Issue Type +	Ma	Location *	WS	
Category	Earthen Levee			GPS Latitude/Longitude		
				Start		End
Item	Erosion / Bank Caving			37.787756 °		37.785971 °
				-121.350851 °		-121.350372 °
DWR ID	DWR_RD2058_01_f_2017_40					
Comment Code						
E2 : Schedule repair of erosion site prior to the next inspection.						
Inspector Comment						
Erosion on the waterside is greater than three feet tall into the levee prism.

Another downstream view of the erosion.

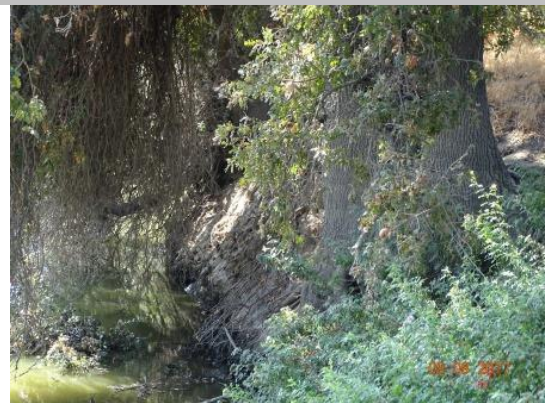
Photo 3 of 5 : FA_2019_RD2058_111_40_20190830_00024.jpg

Upstream view of the erosion site.

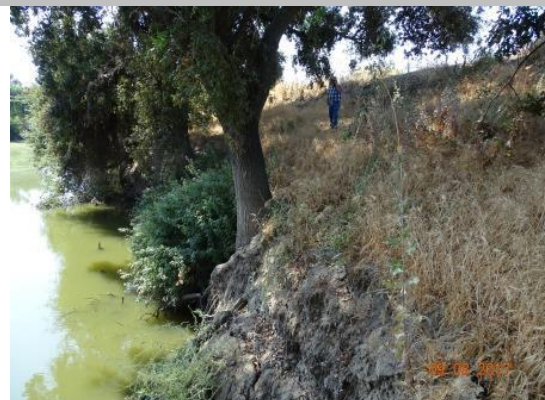
Photo 4 of 5 : FA_2019_RD2058_111_40_20190830_00025.jpg

Another upstream view of the erosion site.

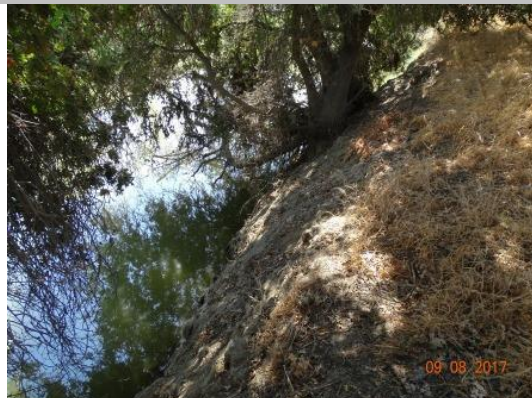
Photo 5 of 5 : FA_2019_RD2058_111_40_20190830_00026.jpg

LM Start	4.63	Rating **	A/W	Issue No.	40 (cont)	
LM End	4.76	Issue Type +	Ma	Location *	WS	
Category	Earthen Levee			GPS Latitude/Longitude		
				Start	End	
Item	Erosion / Bank Caving			37.787756 °	37.785971 °	
				-121.350851 °	-121.350372 °	
DWR ID	DWR_RD2058_01_f_2017_40					
Comment Code						
E2 : Schedule repair of erosion site prior to the next inspection.						
Inspector Comment						
Erosion on the waterside is greater than three feet tall into the levee prism.

Erosion on the bank looking upstream.

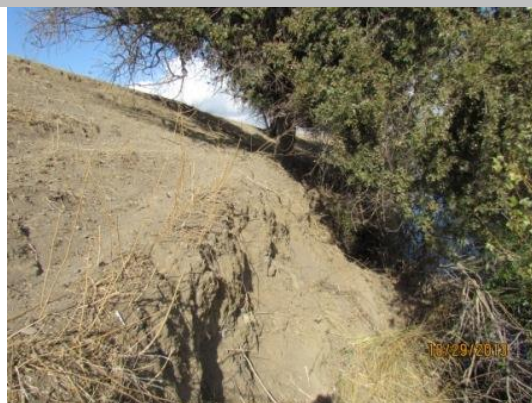
Photo 1 of 3 : FA_2019_RD2058_111_15_20190830_00007.jpg

LM Start	4.76	Rating **	A/W	Issue No.	15
LM End	4.83	Issue Type +	Ma	Location *	WS
Category	Earthen Levee			GPS Latitude/Longitude	
				Start	End
Item	Erosion / Bank Caving			37.785965°	37.785045°
				-121.350374°	-121.349936°
DWR ID	DWR_RD2058_01_f_2013_15				
Comment Code					
E1 : Note and monitor erosion site.					
Inspector Comment					
The erosion has about a 3 foot vertical cut at the waterside levee toe.

View of the erosion at the waterside levee toe.

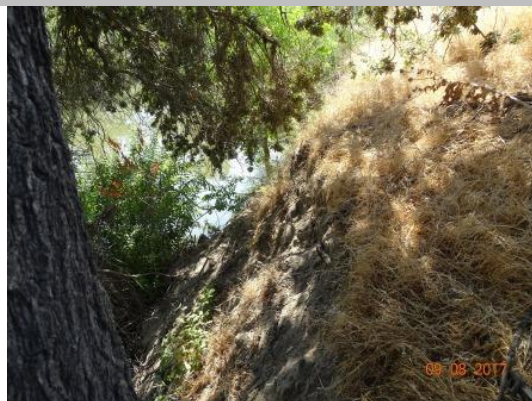
Photo 2 of 3 : FA_2019_RD2058_111_15_20190830_00008.jpg

Upstream view of the erosion.

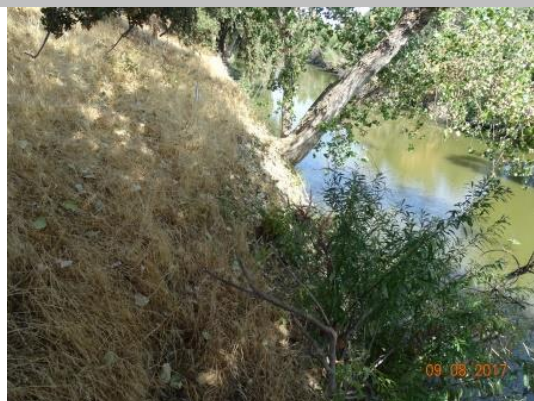
Photo 3 of 3 : FA_2019_RD2058_111_15_20190830_00009.jpg

Downstream view of the erosion site.

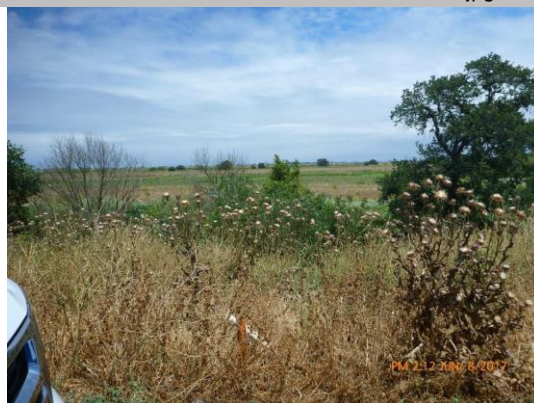
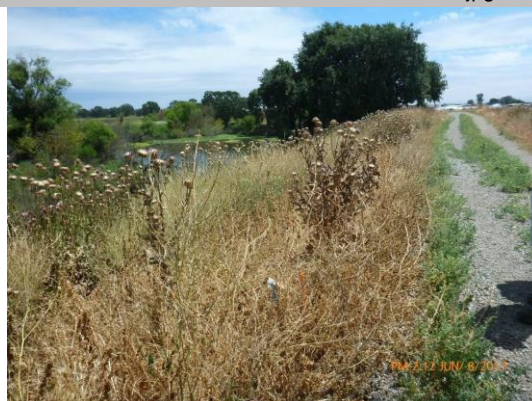
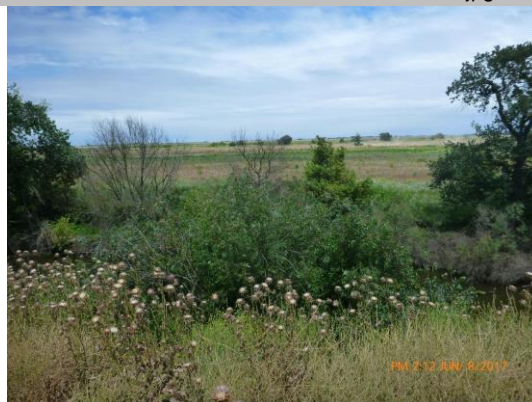
LM Start	4.77	Rating **	A/W	Issue No.	44
LM End		Issue Type +	Ma	Location *	WS
Category	Supplemental			GPS Latitude/Longitude	
				Start	End
Item	2017 Storm Damage			37.785862 °	°
				-121.350303 °	°
DWR ID	FSRP-14-25				
Comment Code					
Inspector Comment					
Levee Evaluation Comments					
Description:					
Site ID No:100					
Site Designation:FSRP-14-25					
Repair Type: Erosion					
Rating:Area of Concern					
Field Date:6/8/2017					
Notes: vegetation too dense to evaluate damage. The erosion has about a 3 foot vertical cut at the waterside levee toe as of the Fall 2017 Inspection. Turned back over to Evaluators for re-assessment.

Notes: vegetation too dense to evaluate damage. The erosion has about a 3 foot vertical cut at the waterside levee toe as of the Fall 2017 Inspection. Turned back over to Evaluators for re-assessment.

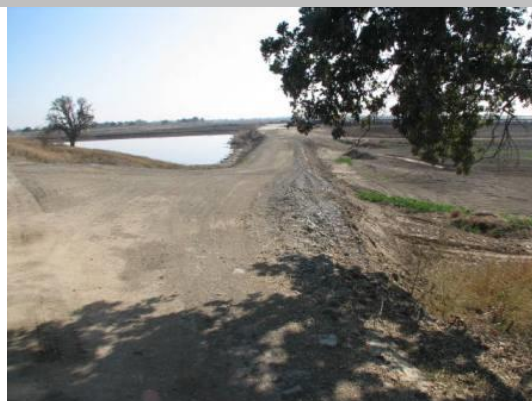
Photo 1 of 3 : FA_2019_RD2058_111_29_20190830_00014.jpg

11/08/2011 New ramp has been constructed by dairy farmer connecting his barns to the levee.

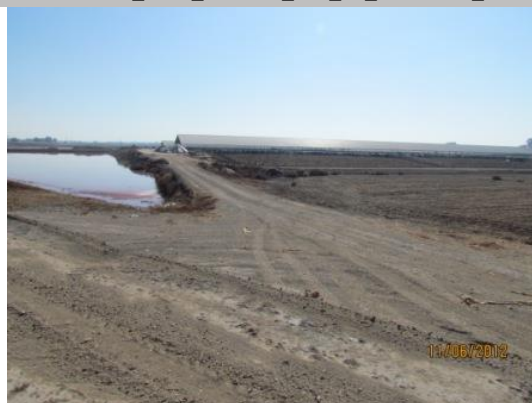
Photo 2 of 3 : FA_2019_RD2058_111_29_20190830_00015.jpg

Completed new ramp constructed by dairy farmer connecting his barns to the levee.

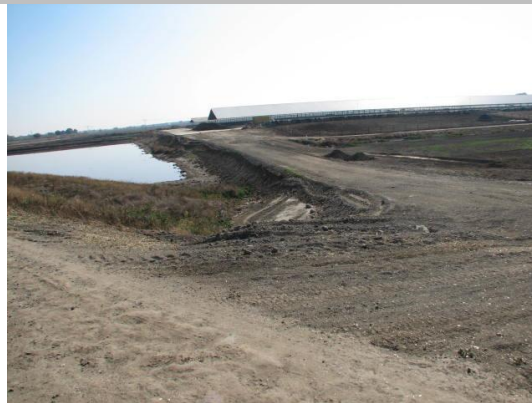
Photo 3 of 3 : FA_2019_RD2058_111_29_20190830_00016.jpg

11/08/2011 New ramp has been constructed by dairy farmer connecting his barns to the levee.

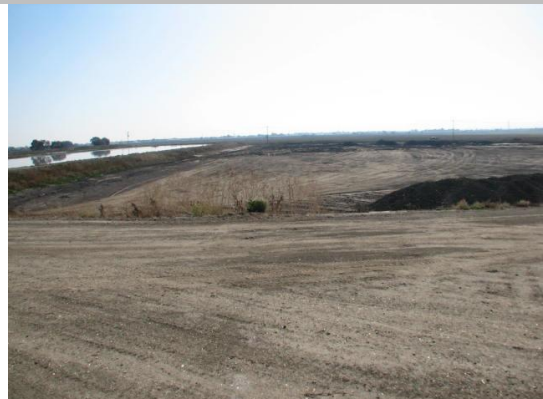
Photo 3 of 3 : FA_2019_RD2058_111_30_20190830_00019.jpg

11/08/2011 Photo shows view from the levee looking to the left of the middle ramp.

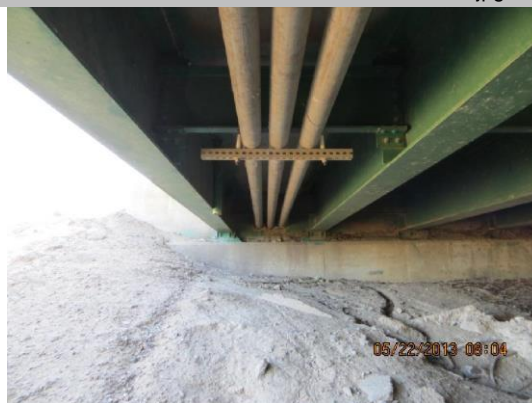
Photo 1 of 3 : UCIP_FA_2019_45871_73100.jpg

Pipes visible under Manthey Rd Bridge at Paradise Cut.

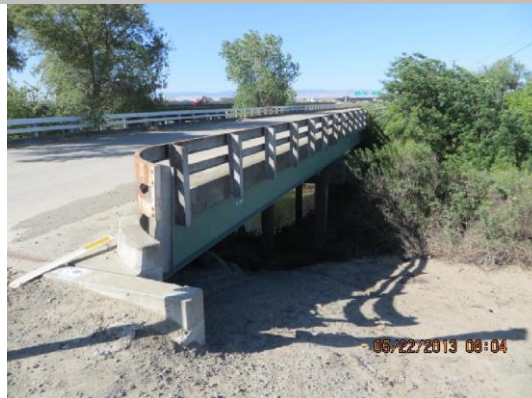
Photo 2 of 3 : UCIP_FA_2019_45871_73101.jpg

Pipes visible under Manthey Rd Bridge at Paradise Cut.

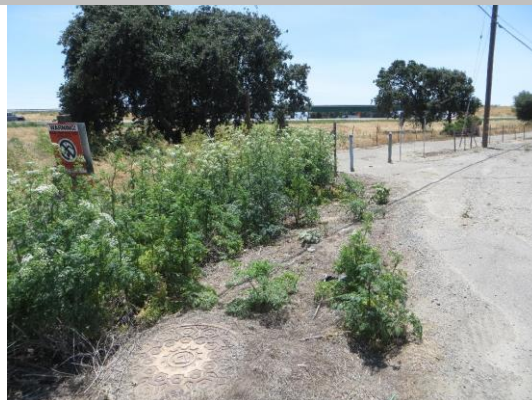
Photo 3 of 3 : UCIP_FA_2019_45871_74132.jpg

Comm sign and Pac Bell manhole appr. 600 ft from LS toe.

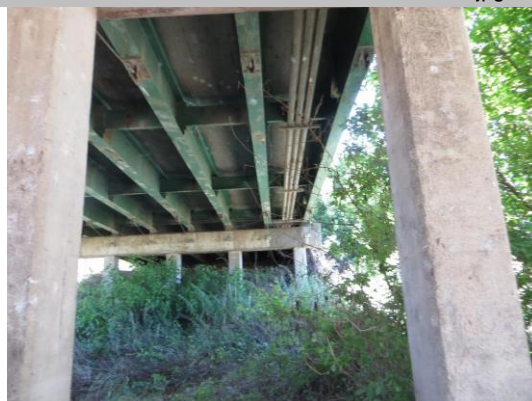
Photo 1 of 3 : UCIP_FA_2019_45768_74267.jpg

Pipes visible under Manthey Rd Bridge at Paradise Cut

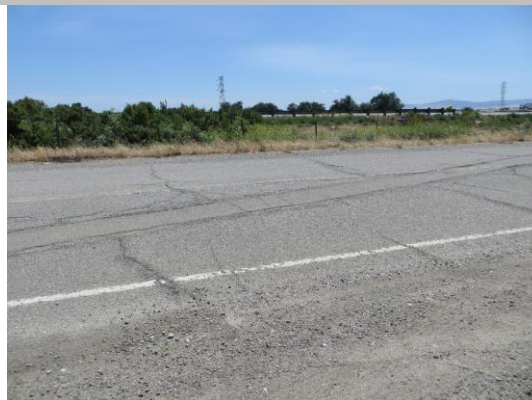
Photo 2 of 3 : UCIP_FA_2019_45768_74268.jpg

Cuts in pavement visible appr. 450 ft from WS toe.

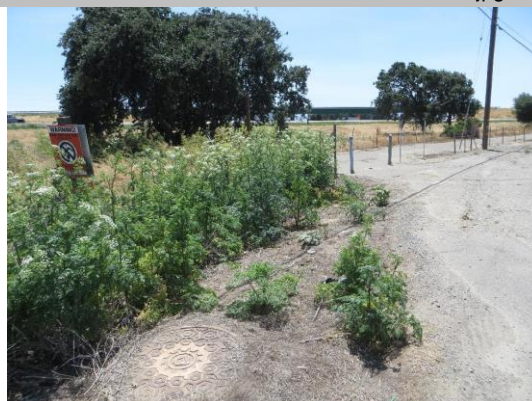
Photo 3 of 3 : UCIP_FA_2019_45768_74269.jpg

Comm sign and Pac Bell manhole appr. 600 ft from LS toe.

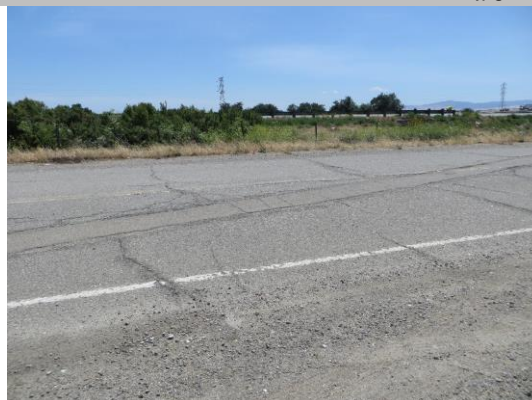
Photo 1 of 3 : UCIP_FA_2019_45769_74270.jpg

Cuts in pavement visible appr. 450 ft from WS toe.

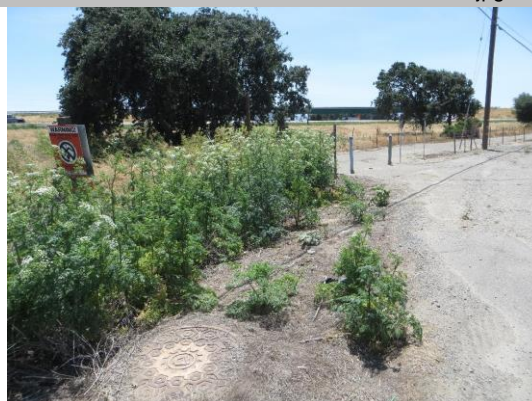
Photo 2 of 3 : UCIP_FA_2019_45769_74271.jpg

Comm sign and Pac Bell manhole appr. 600 ft from LS toe.

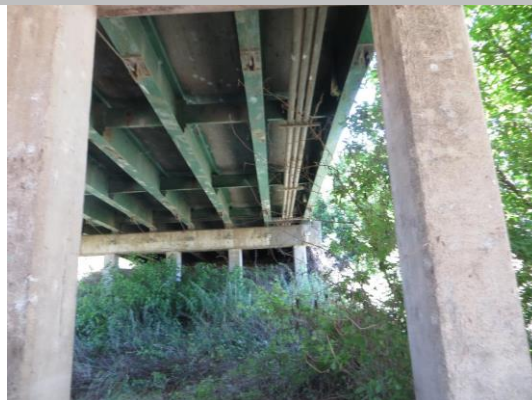
Photo 3 of 3 : UCIP_FA_2019_45769_74272.jpg

Pipes visible under Manthey Rd Bridge at Paradise Cut.
